CYCLIC AND LOW TEMPERATURE EFFECTS ON MICROCIRCUITS

FINAL TECHNICAL REPORT

AUGUST 1975 — AUGUST 1977

MCDONNELL DOUGLAS ASTRONAUTICS COMPANY - EAST

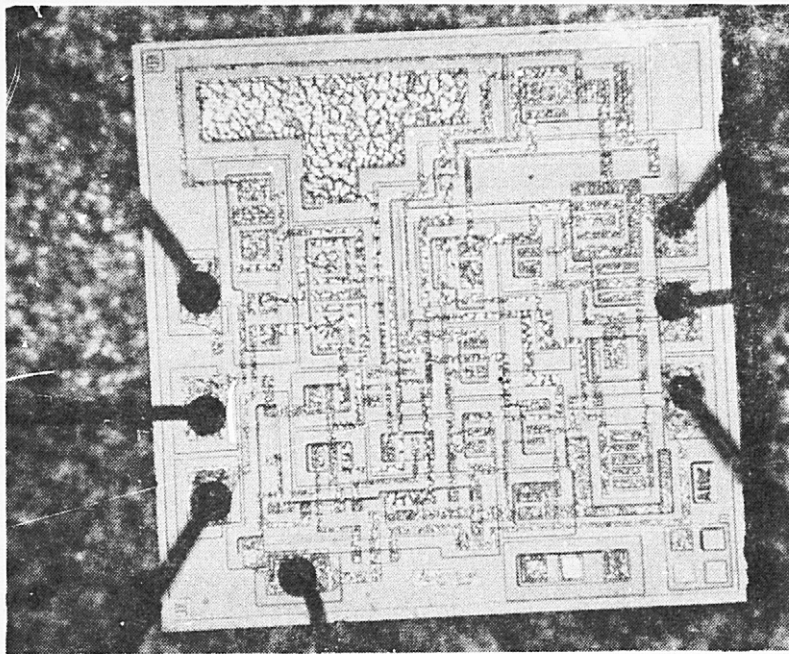
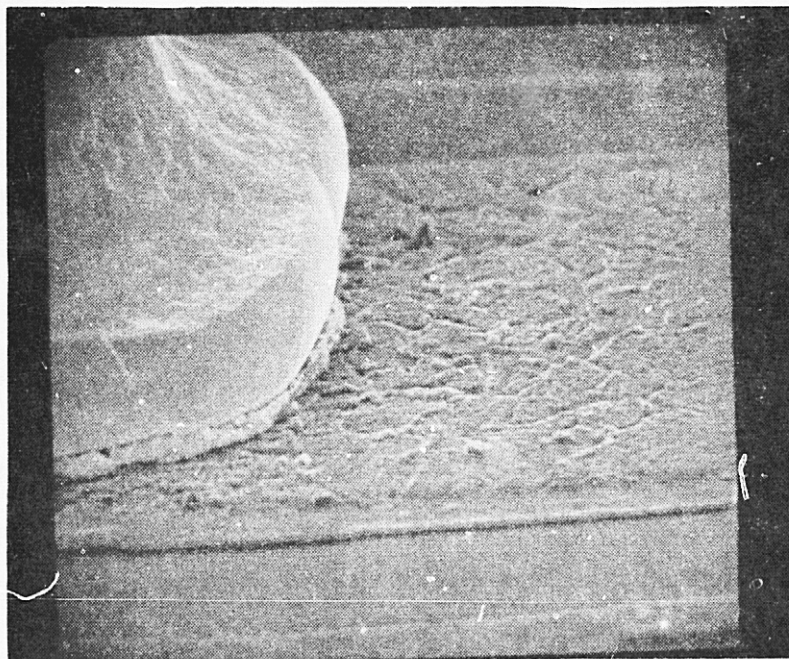
FIGURE 3. EXAMPLES OF ALUMINUM RECONSTRUCTION

The metallization of all devices was unaffected by the LTOT. CTOT, however, produced evidence of aluminum reconstruction [2] (Figure 3) in the three (3) device types with aluminum metallizations. The reconstruction was especially noticeable in the -55°C to 150°C test. Aluminum reconstruction can result in increased sheet resistivity and can promote electromigration [2], but no electrical

a) METALLIZATION WITH GLASSIVATION REMOVED

b) SEM PHOTO OF ALUMINUM RECONSTRUCTION

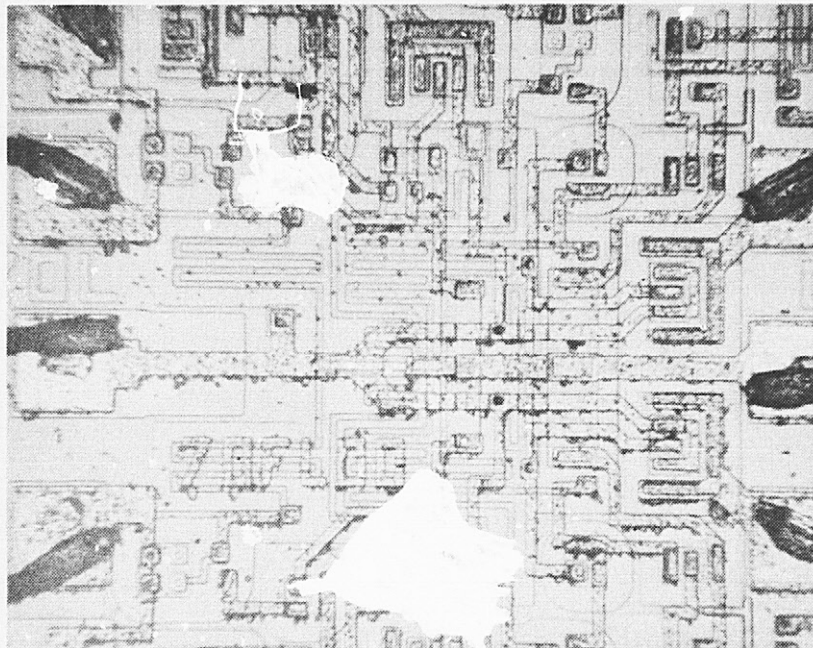
FIGURE A16. EXAMPLE OF DIE WITH ACCUMULATION OF CONTAMINATION
ALONG THE EDGES OF THE METAL STRIPES.

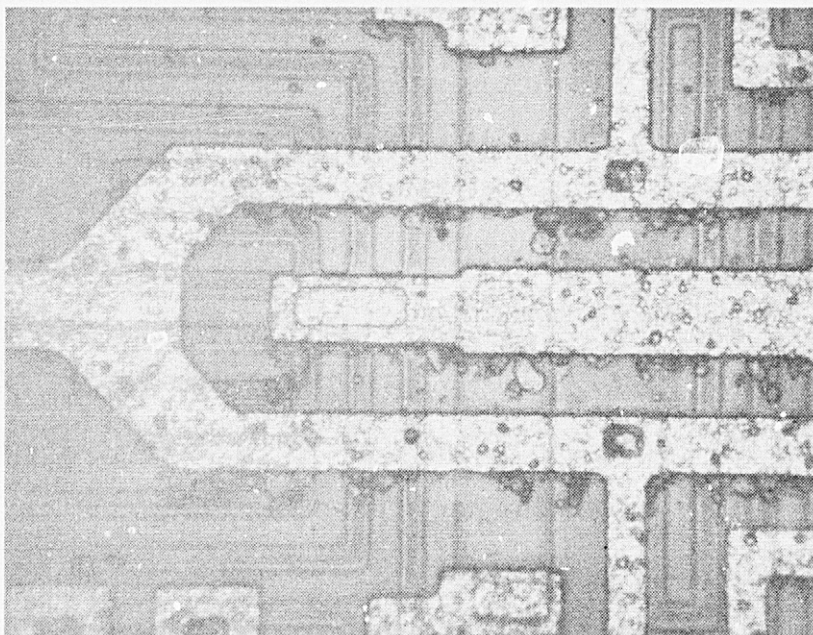
FIGURE A17. EXAMPLE OF THE TRANSPARENT, FLAKE-TYPE CONTAMINATION.

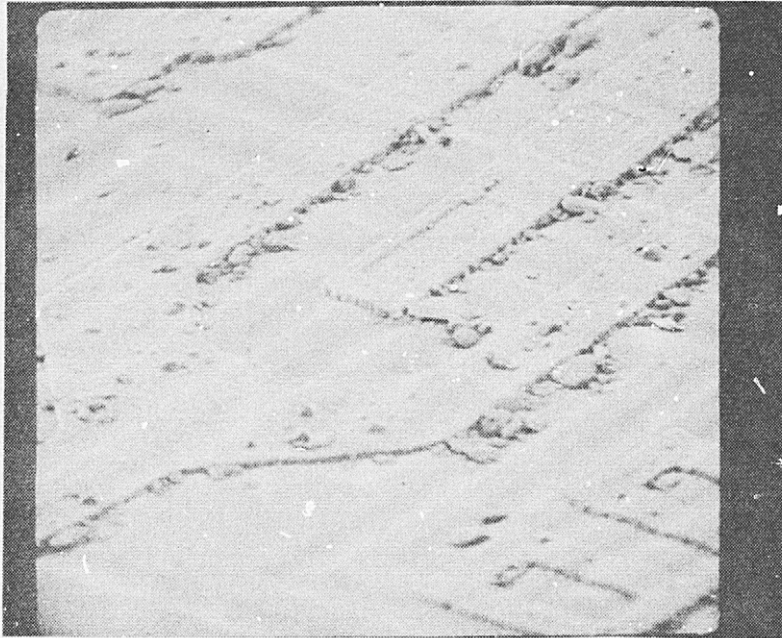
FIGURE A18. SEM PHOTO OF THE FLAKES SHOWN IN FIGURE A17.

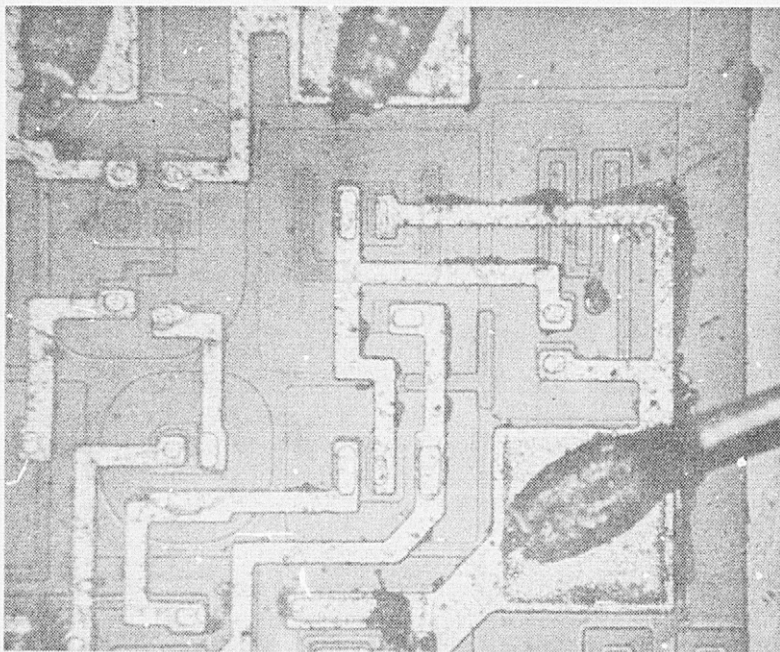
FIGURE A19. OPTICAL PHOTOGRAPH OF THE RESIDUE-TYPE CONTAMINATION

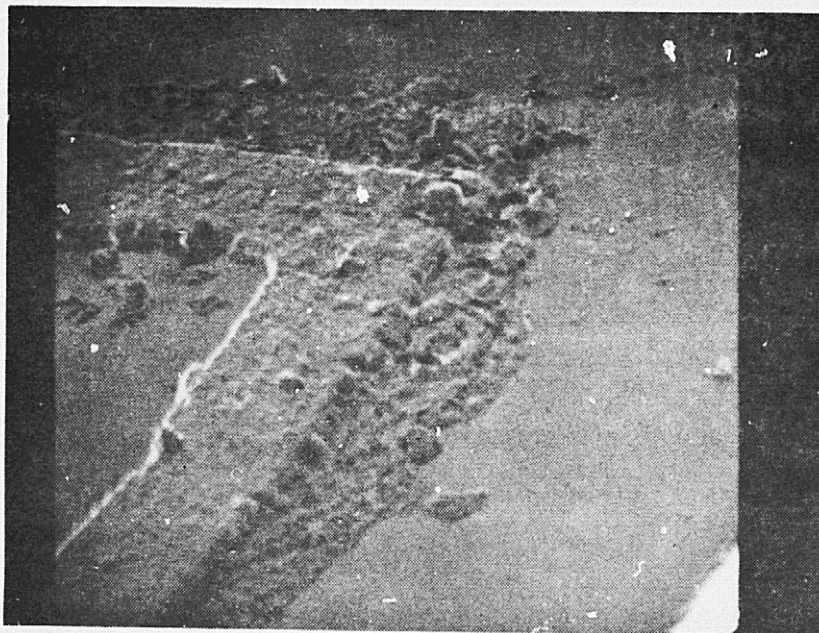
FIGURE A20. SEM CLOSE-UP OF THE CONTAMINATION SHOWN IN FIGURE A19.

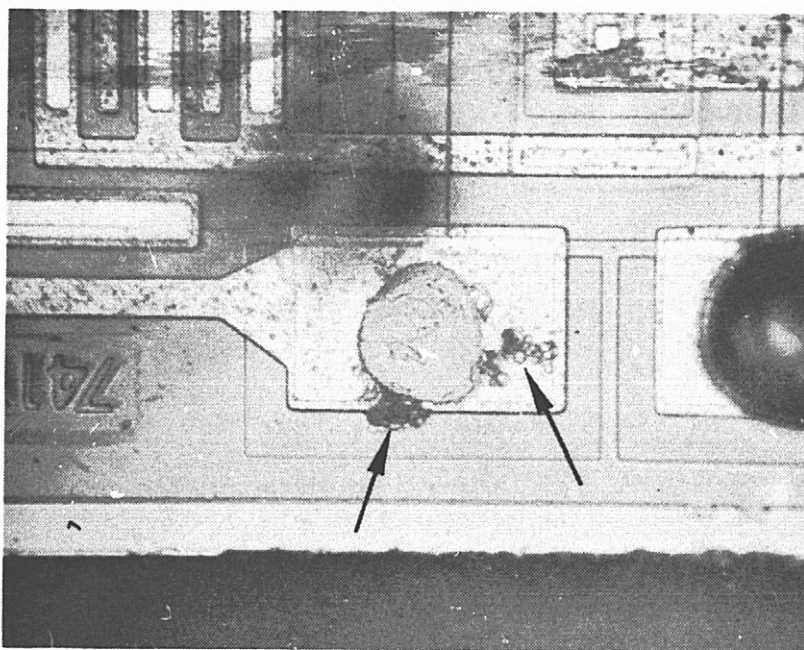
FIGURE A51. LIFT-OFF PATTERN OF THE PIN 5 BOND.
ARROWS DENOTE THE CONTAMINATION.

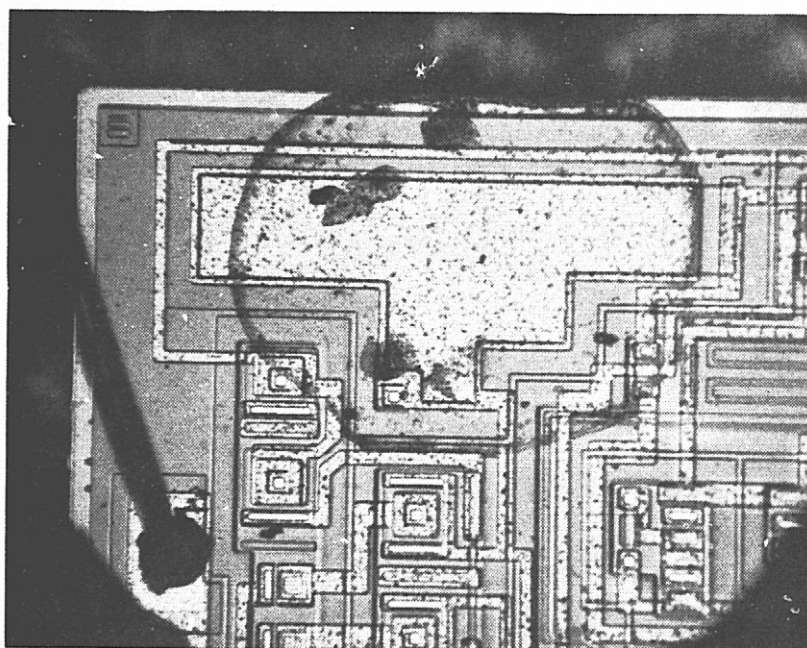
FIGURE A52. LARGE STAIN OVER THE MOS CAPACITOR

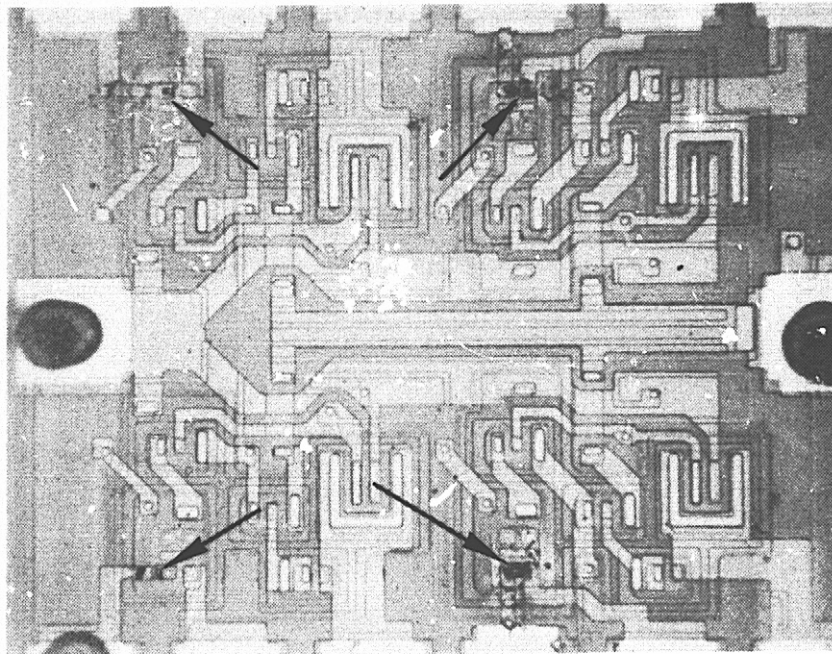
105X S/N 311
FIGURE B2. DIE PHOTO SHOWING THE DAMAGED INPUTS (ARROWS).

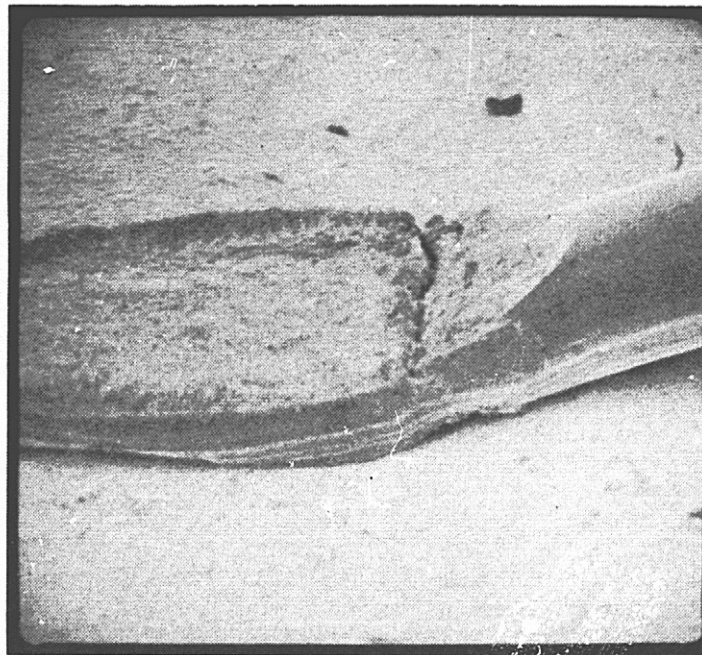
FIGURE B5. SEM PHOTO OF A CRACKED WIRE BOND AT PIN 12.

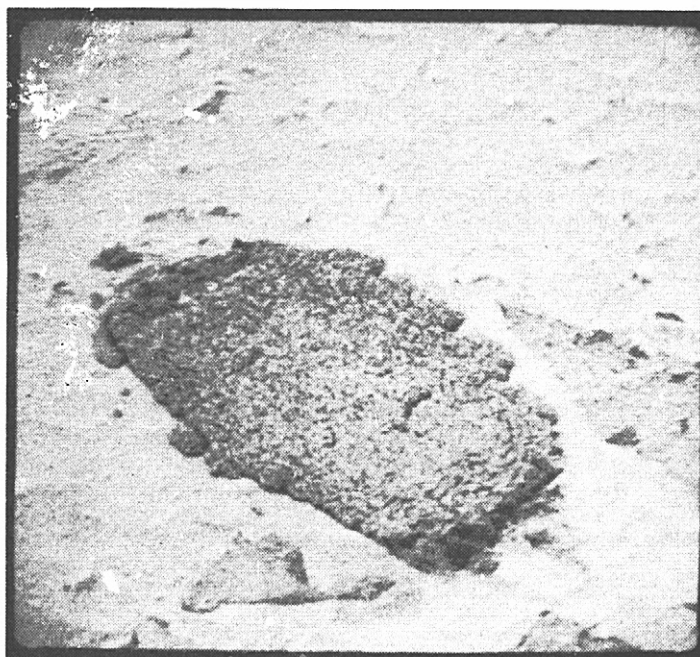
FIGURE B6. INTERMETALLICS ON THE PIN 12 LEAD FRAME
REVEALED BY DISSOLVING THE BOND FOOT.

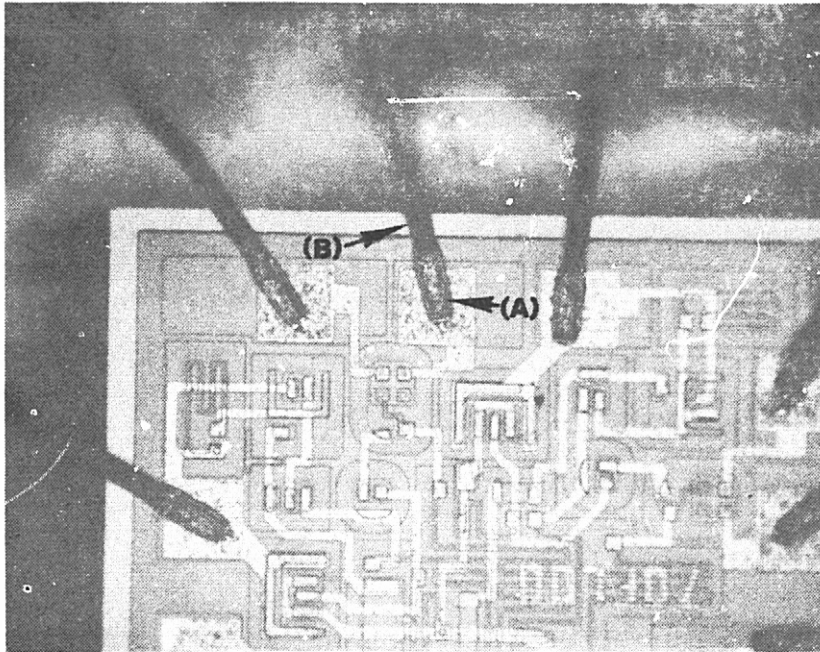
FIGURE B7. MISPLACED PIN 1 WIRE BOND (A) SHOWING THE LOCATION OF THE WIRE-DIE SHORT (B)

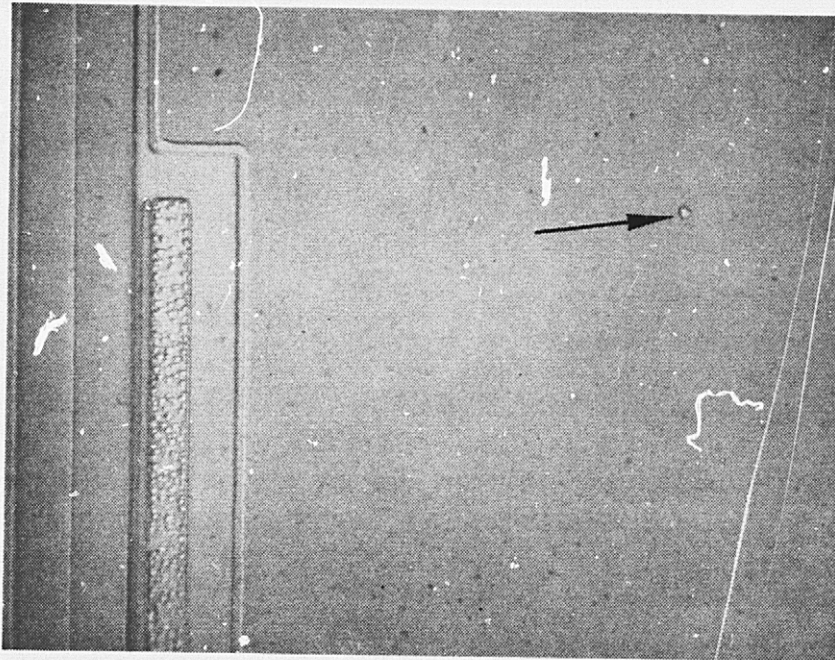
SHORTED MOS CAPACITOR - Two parts were latched negative at all three measurement temperatures. The failures were traced to a short (9 ohms and 20 ohms) in the internal 30 picofarad MOS compensating capacitor, C1. Removal of the aluminum electrode revealed, in each instance, a pinhole in the SiO_2 dielectric as shown in Figures B9 and B10. The failure mechanism involved migration of aluminum through the pinhole during stress and the pinholes most likely were caused by pinholes in the photoresist polymer during contact window etching.

FIGURE B9. PINHOLE (ARROW) IN THE SiO_2 DIELECTRIC OF C1

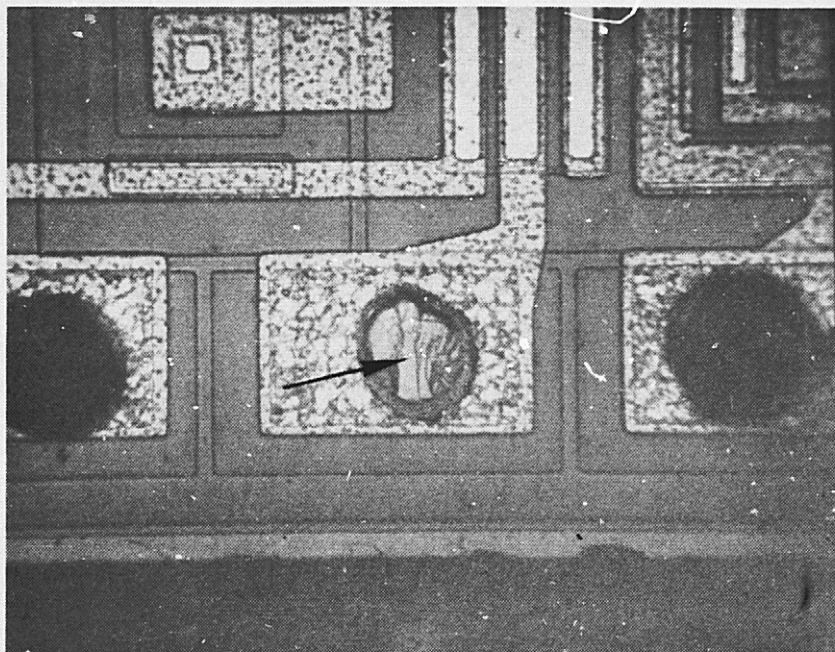
FIGURE B11. LIFT-OFF PATTERN OF THE PIN 6 BOND SHOWING
THE CRATER (ARROW) IN THE SILICON.

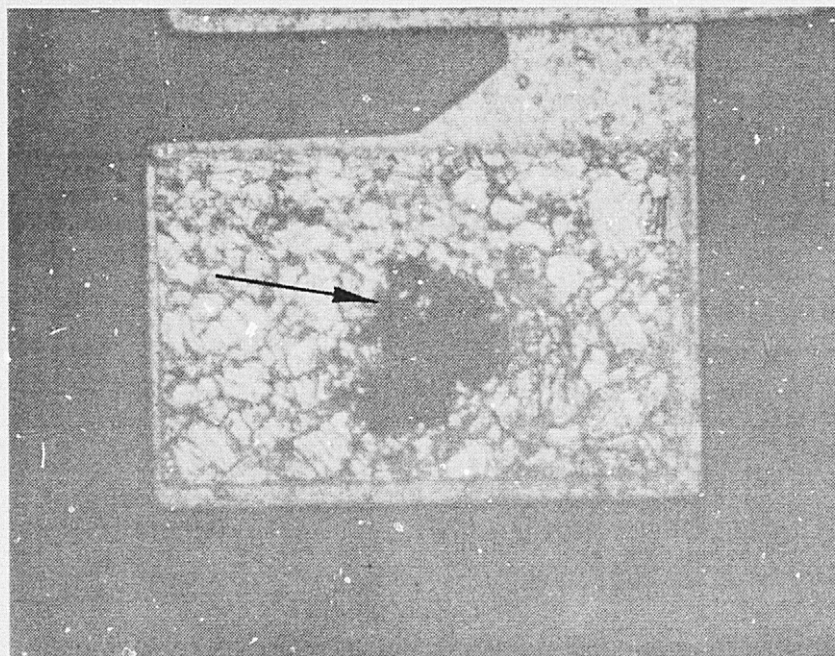
FIGURE B12. LIFT-OFF PATTERN OF THE PIN 7 BOND SHOWING
THE MOUND OF INTERMETALLICS (ARROW).

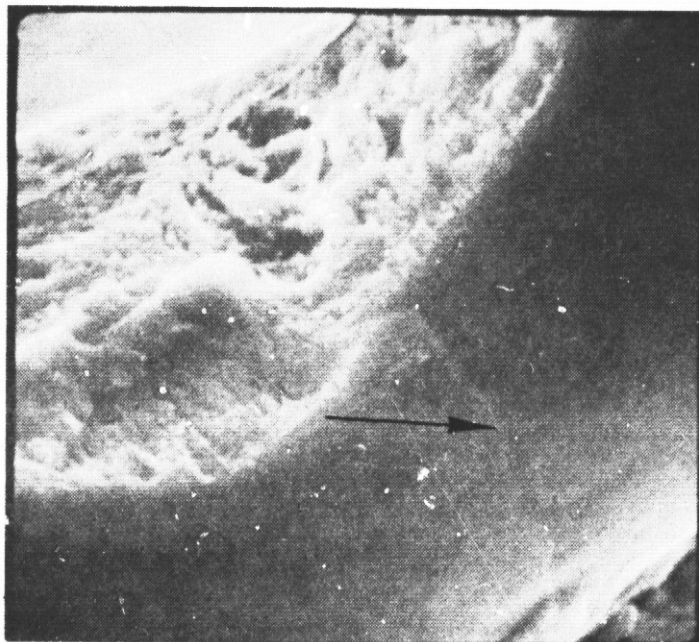
FIGURE C8. FAINT CRACK (ARROW) AT THE HEEL OF THE
BOND SHOWN IN FIGURE C7.

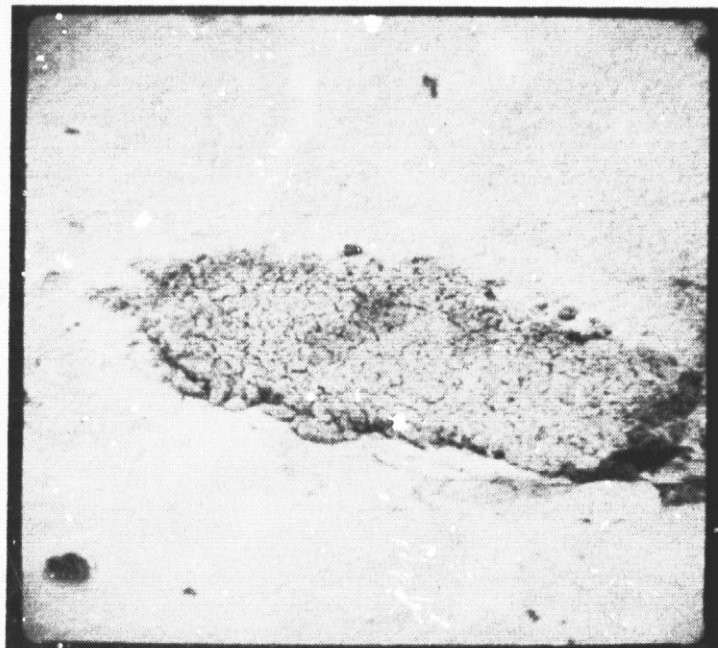
FIGURE C14. INTERMETALLIC GROWTH UNDER THE FOOT OF THE BOND SHOWN IN FIGURE C13

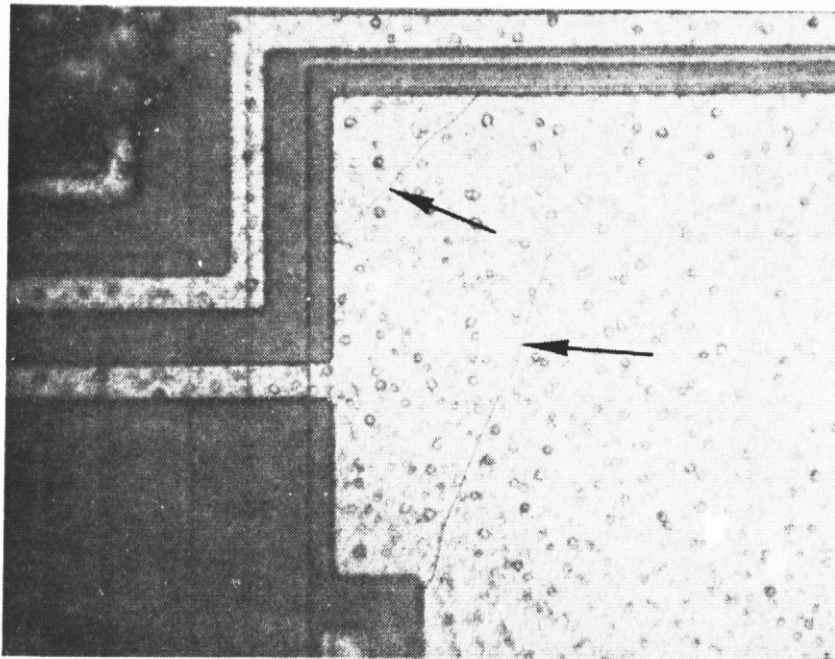
FIGURE C16. CRACKS IN THE GLASSIVATION OVER THE MOS CAPACITOR OF THE GROUP III PART.

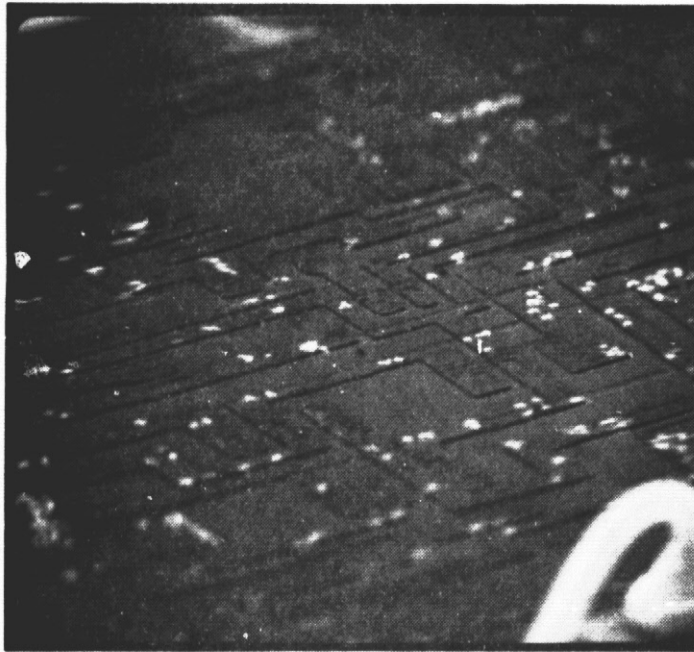
FIGURE C31. SEM PHOTO OF THE SURFACE OF A PART CONTAMINATED WITH DROPS OF FOREIGN MATTER (WHITE SPOTS).

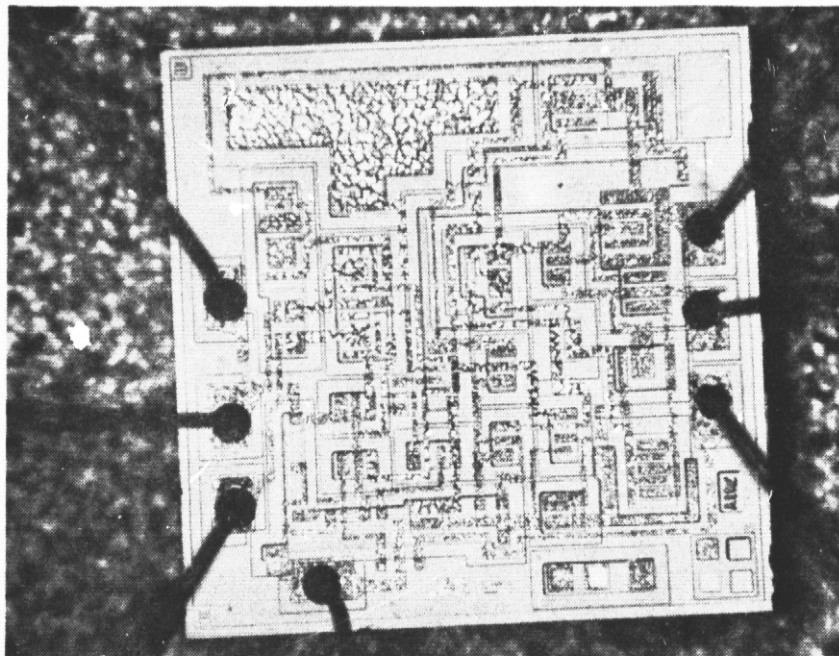
FIGURE C42. EXAMPLE OF THE EXTENT OF ALUMINUM RECONSTRUCTION REVEALED BY GLASSIVATION REMOVAL.

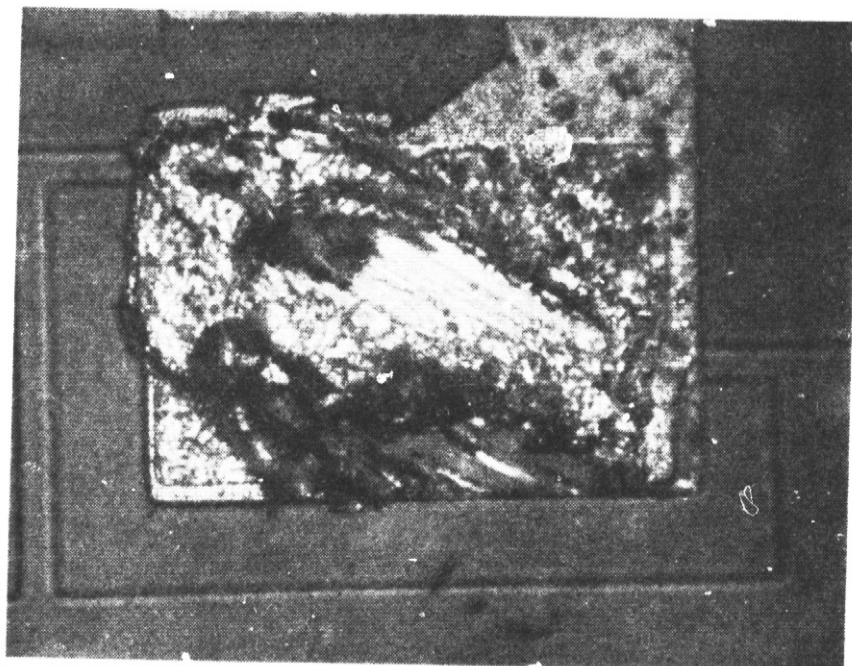
FIGURE C44. SMEARED PIN 7 BOND PAD.

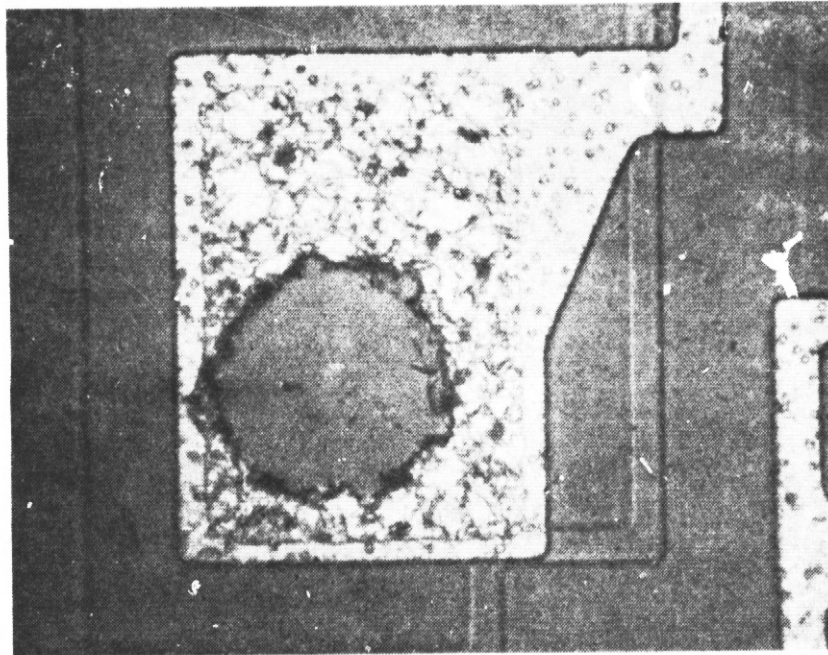
FIGURE C45. EXAMPLE OF VOID FAILURE DUE TO SEPARATION OF THE ALUMINUM FROM THE SiO_2 (PIN 1).
